LOSS BULLETIN

EQUIPMENT BREAKDOWN LOSS

Condominium Suffers Blown Electrical Panel

Loss Bulletin
Number 1

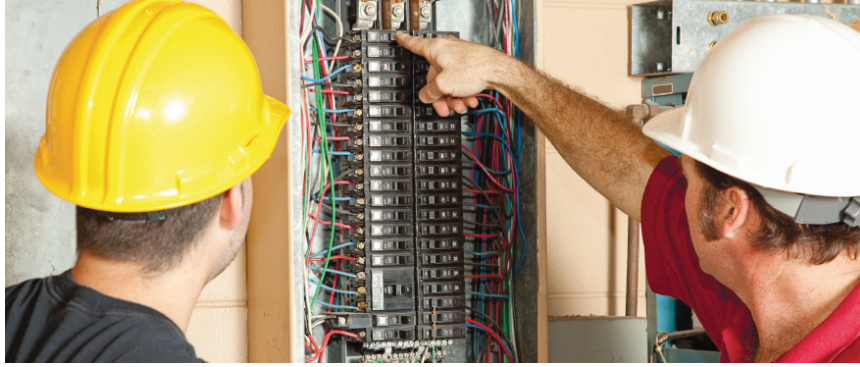
At approximately 7:00 p.m. the building superintendent of a condominium apartment building discovered that a power failure had shut down all equipment in the mechanical room. An electrical contractor was called and proceeded to replace a blown 400 Amp fuse. The contractor then restored power without first determining the cause of the blown fuse. Upon switching on the 400 Amp breaker which controlled the power supply to the air conditioning unit, a small explosion resulted, completely destroying the panel.

The control panel had not been fitted with a moisture barrier and was not of weatherproof construction. Moisture accumulation, combined with insulation deterioration between the penthouse distribution panel and the chiller control switch, is the suspected cause of the loss.
