LOSS BULLETIN

NUMBER 13

OPERATOR ERROR DAMAGES BORING MILL

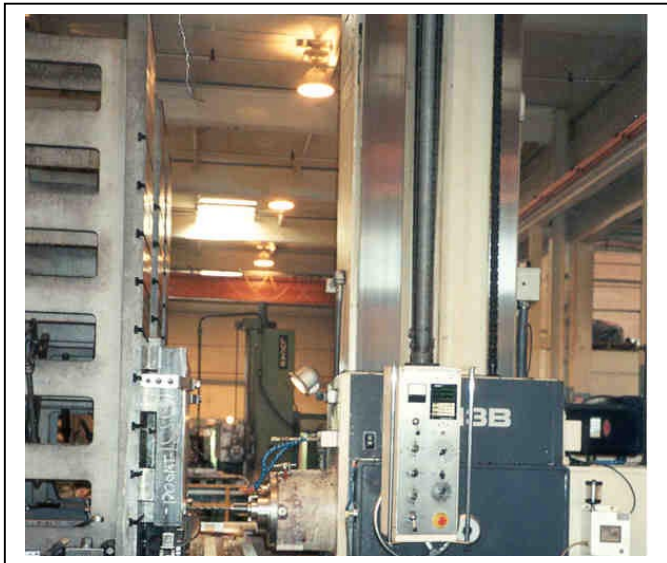
The operator of this machine had changed the machine to manual control to drill holes horizontally in the workpiece. As the cutting head was being withdrawn from one of the holes being machined, the operator proceeded to move the cutting head to the location of the next hole. In his haste, the operator neglected to ensure that the cutting head was fully withdrawn before the assembly was moved vertically. The collision resulted in extensive damage to the cutting head spindle and ceramic shaft bearings.

Despite the fact repairs were fully expedited, it still took almost two months to obtain the replacement spindle assembly from the foreign based manufacturer.
