DRY CLEANER'S BOILER EXPERIENCES RUPTURE, CAUSING SHUTDOWN OF OPERATION

LOSS DETAILS

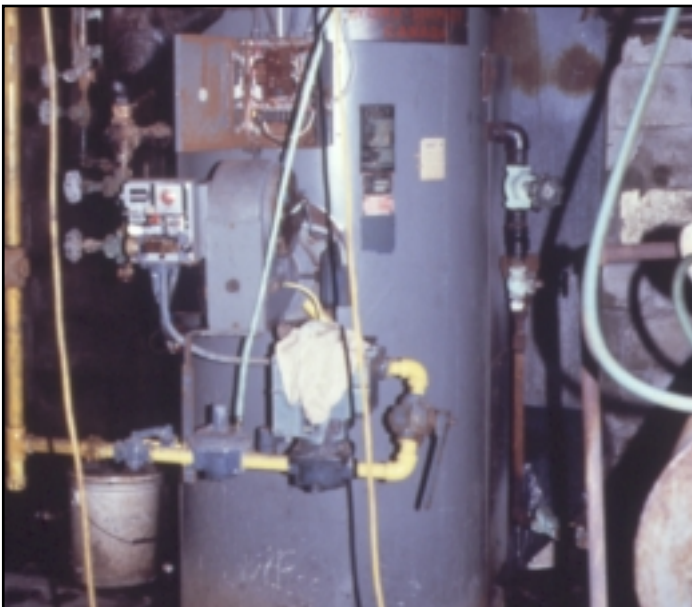
During an inspection of this boiler, which provided 100-psi steam to clothing presses, an 8-inch bulge was discovered. It was located inside, on the waterside of the boiler and caused a 1-inch crack on the inner shell weld. This is a common occurrence due to heavy scale and sediment buildup.

It was determined, in the best interest of the insured, to replace this boiler with a new one within seven days, rather than repair it, taking three weeks. In the replacement process, walls within the dry cleaner were removed and reinstalled, allowing access.

To prevent a reoccurrence, daily blowdowns and a water treatment plan were instituted by the insured.
