2-COLOUR PRINTING PRESS SUSTAINS DAMAGE

LOSS DETAILS

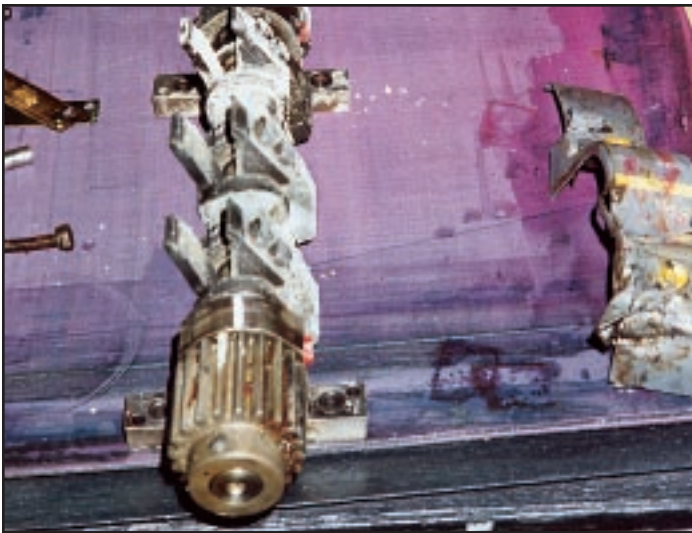
One of the gripper bars which feeds paper or cardboard into the press became jammed. The shaft on this bar is approximately 1/2" diameter and 30" in length and is protected at each end by a metal guard. One of the guards worked loose and became jammed between the fingers of the gripper bar, stalling the machine and bending the gripper bar shaft out of shape.
